Gibson G101 Neon Bulb Replacement for Percussion & Repeat

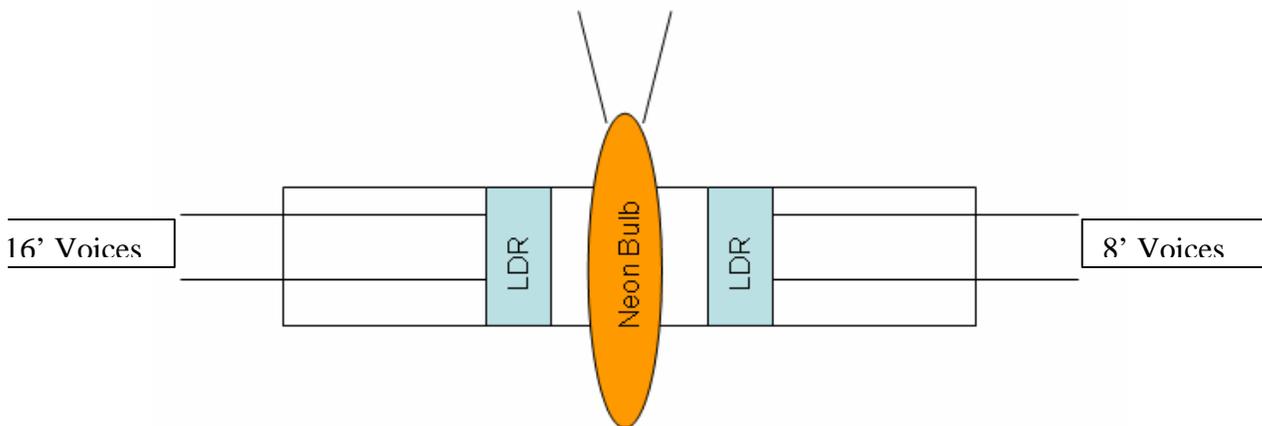
A common thing which can go out which affects the percussion and repeat functions is the LDR/Neon Bulb array located to the far right of the tab switches and is depicted in the first photo below. It can be somewhat difficult to diagnose the bulb as the source of the problem since there are other electronics that play into this as well. I would recommend first scratching away a small amount of the grey metallic goop that covers the bulb to see if it is flashing when the repeat knob is turned on. If the bulb flashes then either 1) The bulb has lost brightness due to age and is too dim to trigger the LDRs or 2) One or both of the LDRs are bad. I would recommend replacing the bulb first since it is much easier than replacing the LDRs. If the bulb does not flash then either 1) The bulb has burned out 2) Something else has gone bad in the repeat circuitry. Take a volt meter and touch it (careful don't short something out!) to the leads on the bulb. An analog volt meter set to 100vdc should work best but if using a digital meter, set the repeat to very slow so the change is noticeable. If you read voltage in an on/off pattern, then your repeat circuit is OK and the bulb is bad. Here is a diagram of how the LDR/Neon Bulb array works

* Repeat knob controls flashing rate of Neon Bulb. When light strikes the LDR (light dependent resistor), the value of the resistor drops, allowing the signal to pass. Note that one LDR is for the 8' brass and string voices and the other is for the 16' brass and string voices. If your percussion and repeat work only on 8' OR 16' voices, then your problem could be a bad LDR and not the neon bulb.

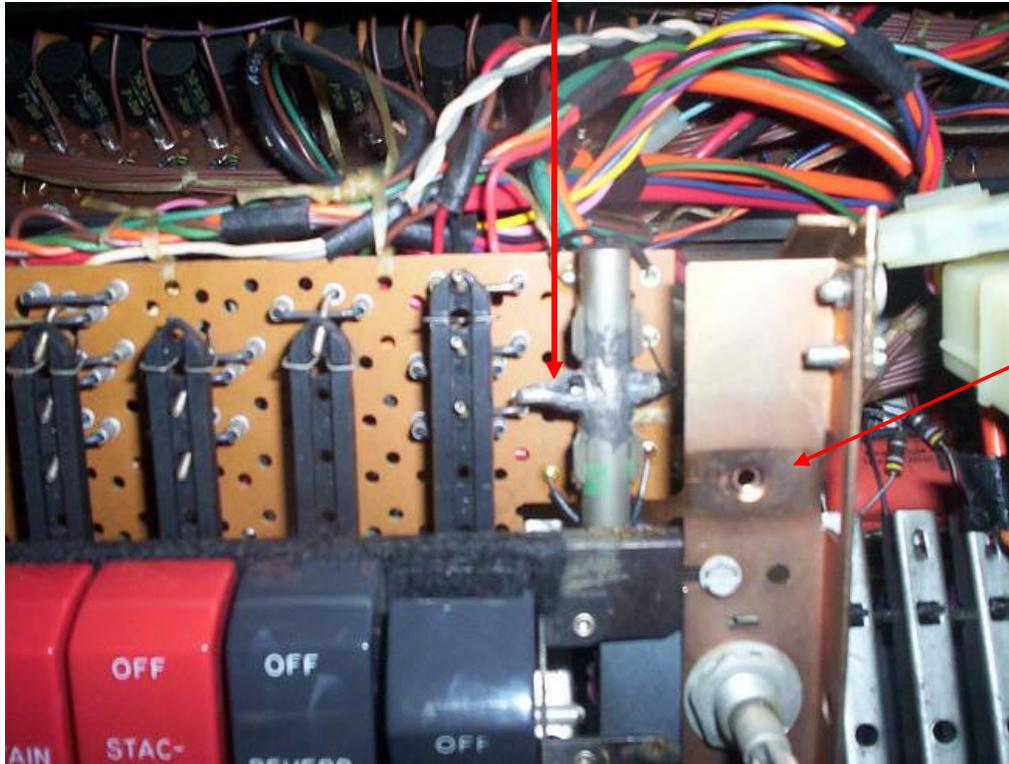
This is the original LDR assembly with neon bulb cemented in the middle of the metal calendar

Note that metal rail has been removed for easier access to the solder points

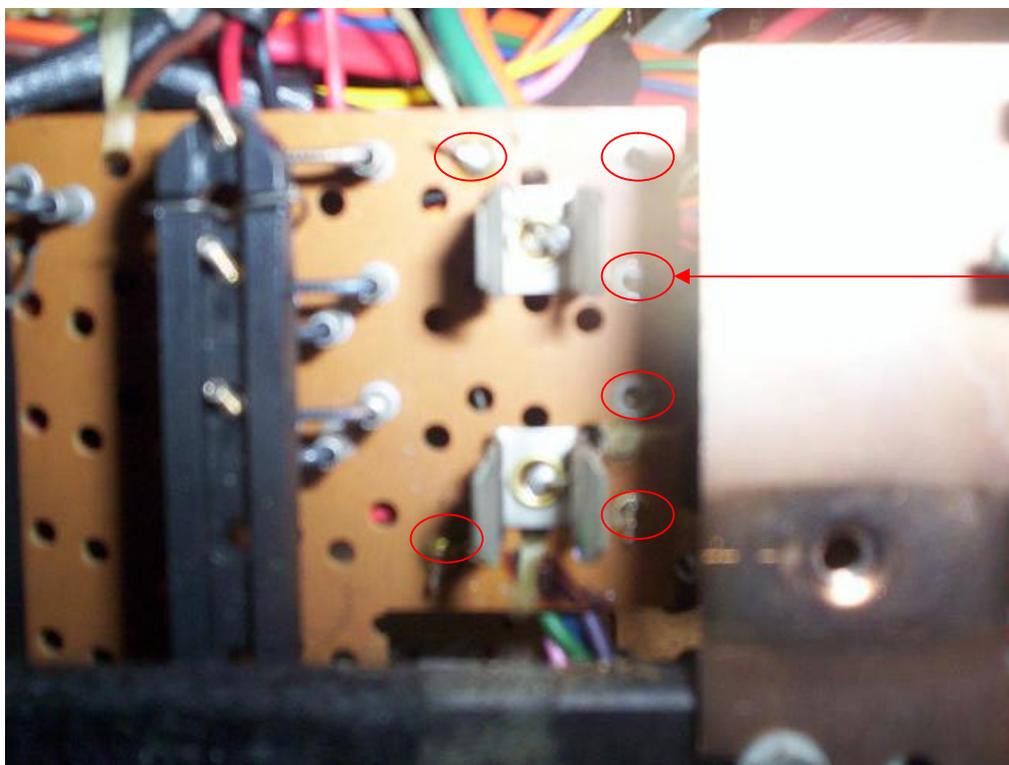
Solder Points (be carefull not to melt any plastic items such as the tabs or tab levers when using the iron in this area)

Desolder the six wires connecting it and the bulb to the board and remove it:
